**LAND AT
GIB LANE
BLACKBURN**

**FLOOD RISK ASSESSMENT
& OUTLINE DRAINAGE STRATEGY**

Ref: FRA 13 1077-FINAL

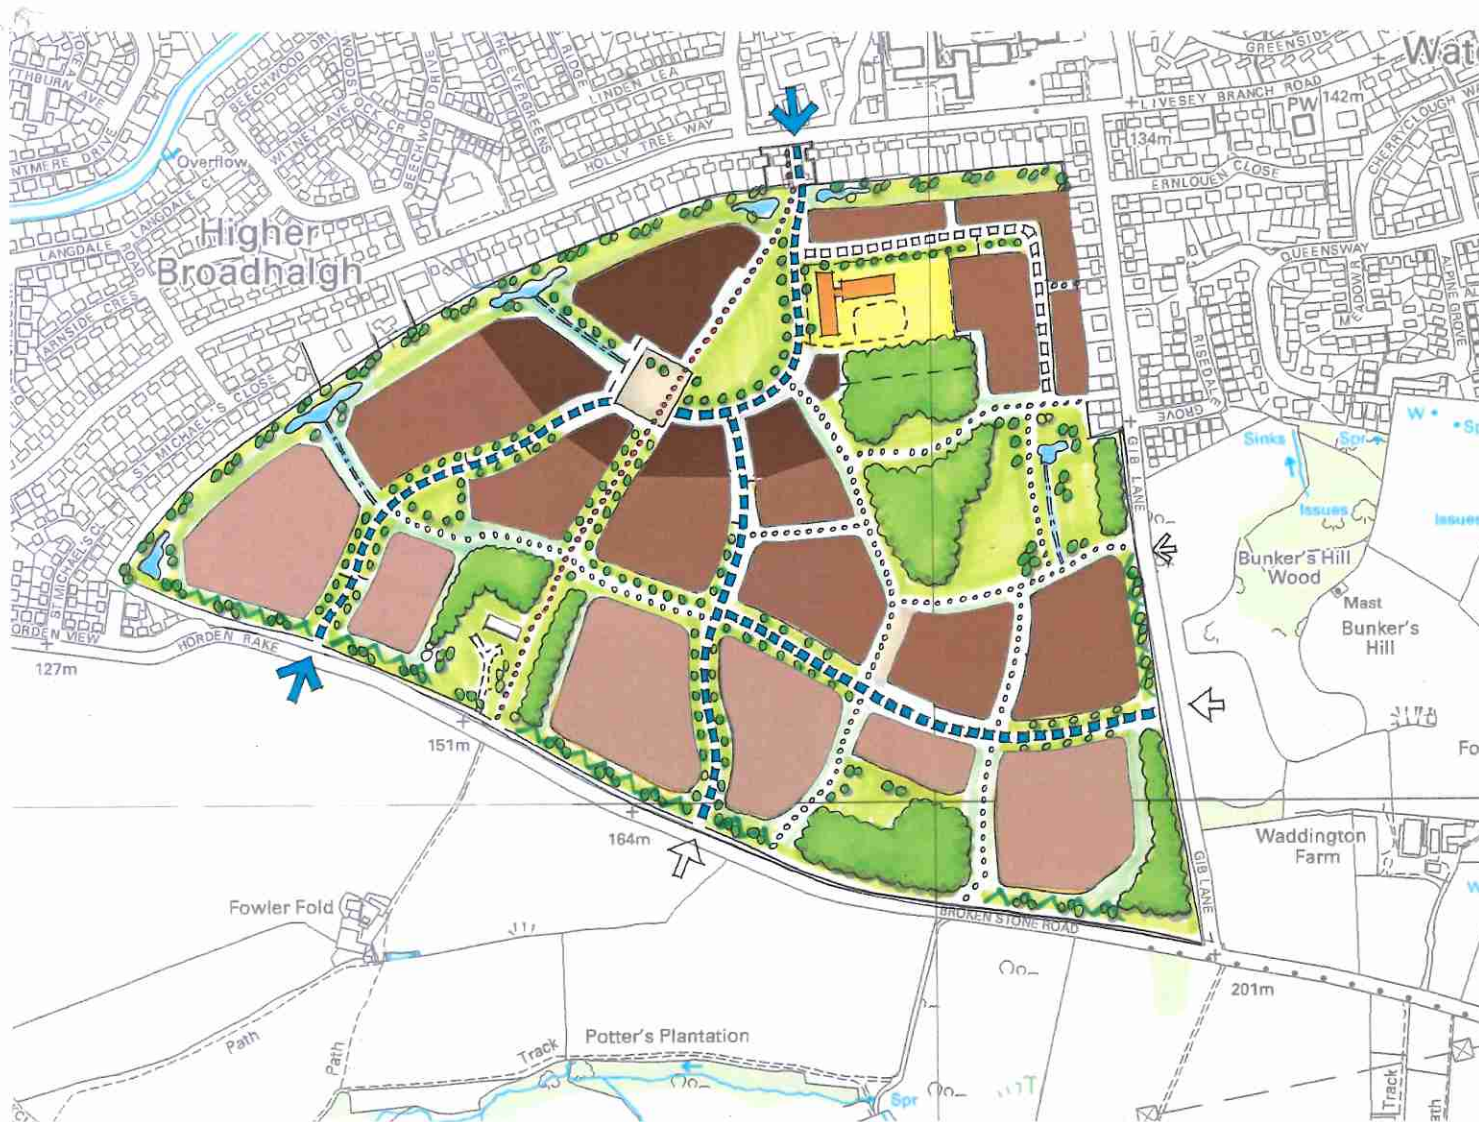
GIB LANE, BLACKBURN | LANDSCAPE STRATEGY (LS001) | DRAFT (NOT TO SCALE) | URS JANUARY 2014

SUDS features.

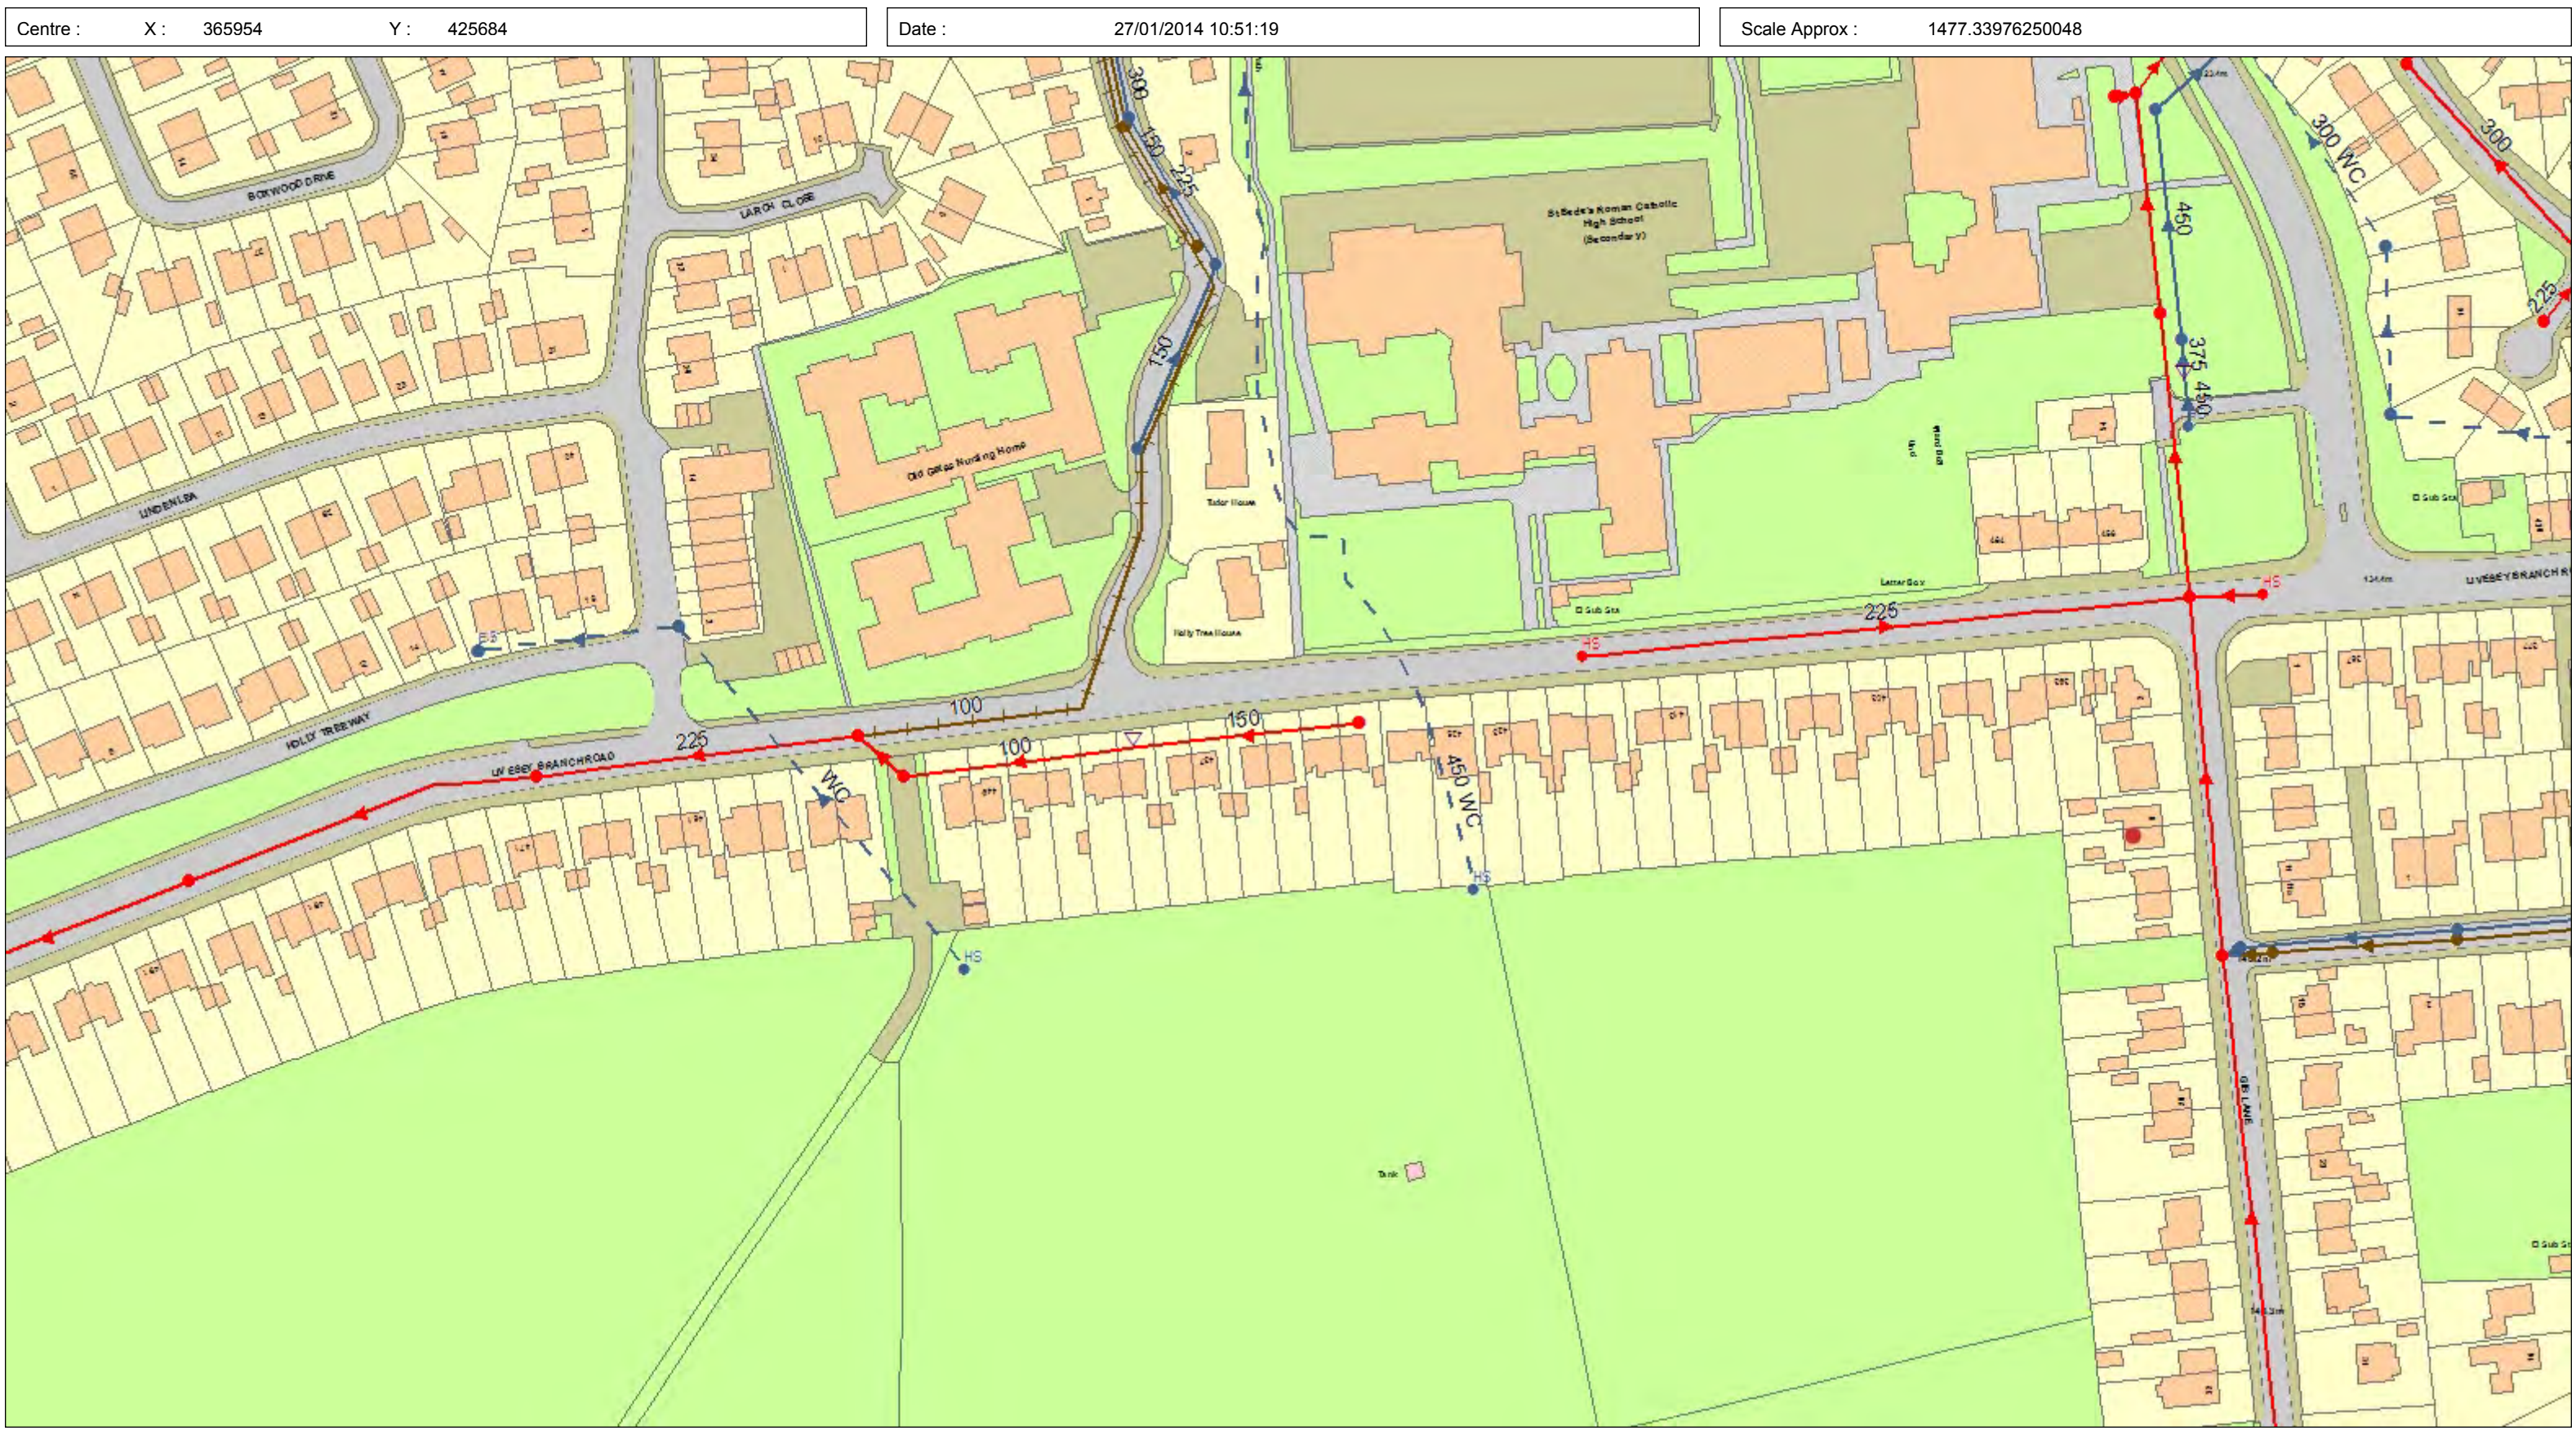
UU Maps for Safe Dig

The position of the underground apparatus shown on this plan is approximate only and is given in accordance with the best information currently available. The actual positions may be different from those shown on the plan and private service pipes may be shown by a blue broken line. United Utilities Water will not accept liability for any damage caused by the actual position being different from those shown.

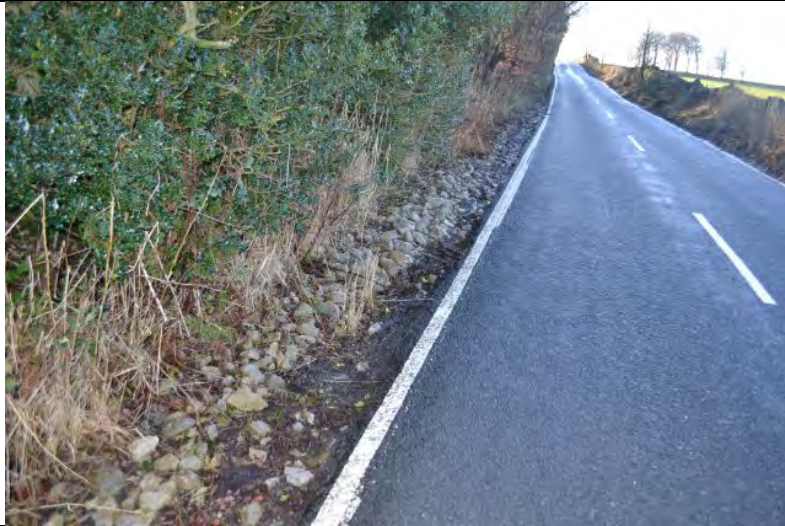
Photograph 1 (facing S):
View of roadside filter drain on Gib Lane falling north intercepting road and hillside runoff to the east of the plot.

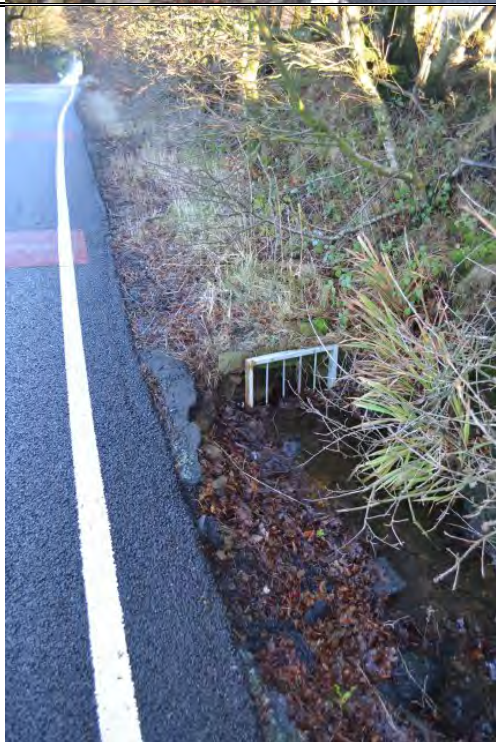
Photograph 2 (facing N):
Entrance to culvert that appears to cross Gib Lane towards watercourse in east Cockridge Woods, connecting verge drains and gullies.

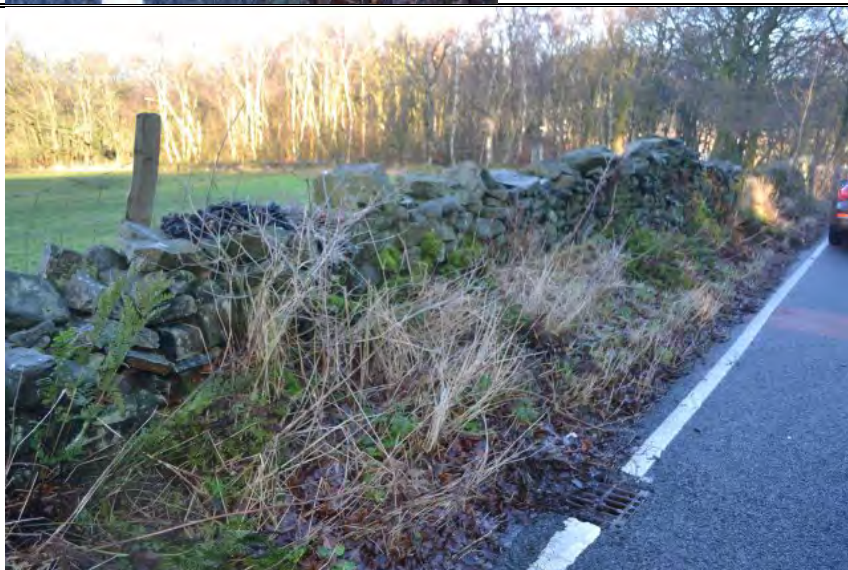
Photograph 3 (facing NW):
Gully on Gib Lane likely to connect to culvert crossing the lane to cross the plot.

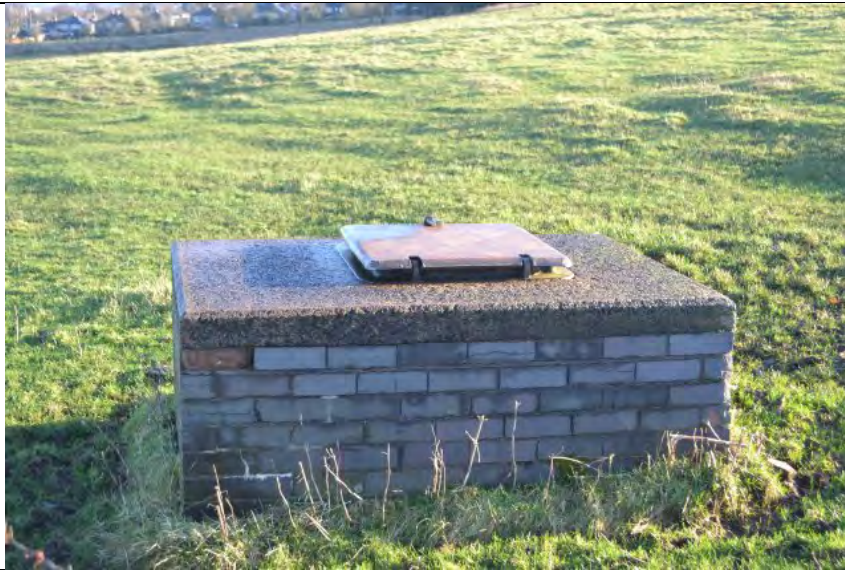
Photograph 4 (facing E):
Valve chamber on water main crossing the site.

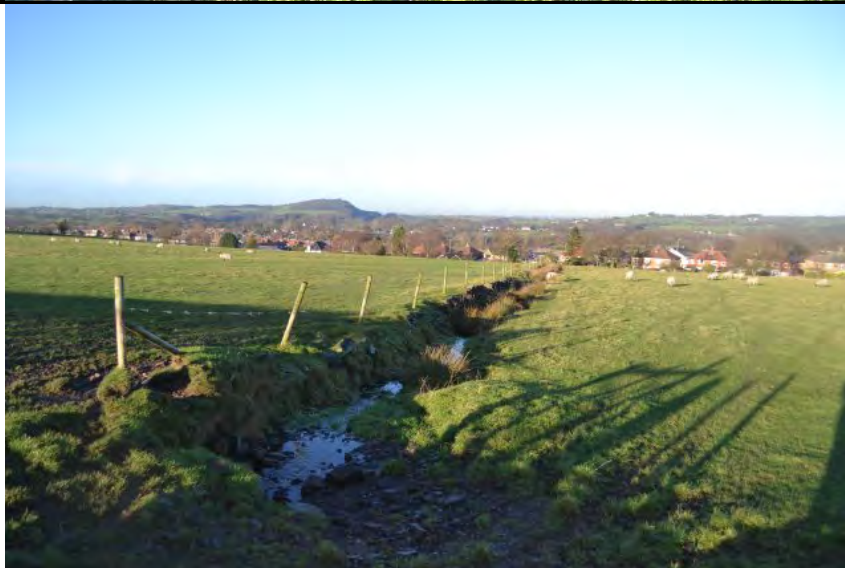
Photograph 5 (facing NW):
Watercourse downstream of crossing of the Witton Weavers Way.

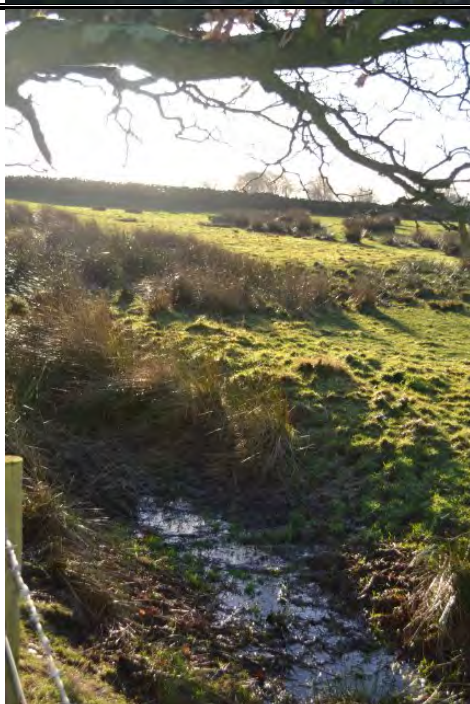
Photograph 6: (facing S)
Upper end of watercourse as above fed by land drains.

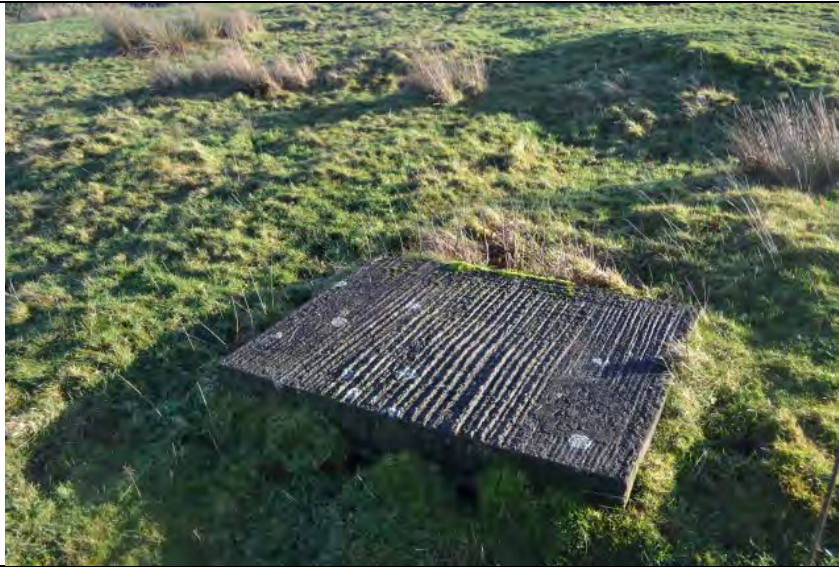
Photograph 7 (facing E):
Sealed chamber near
watercourse above.

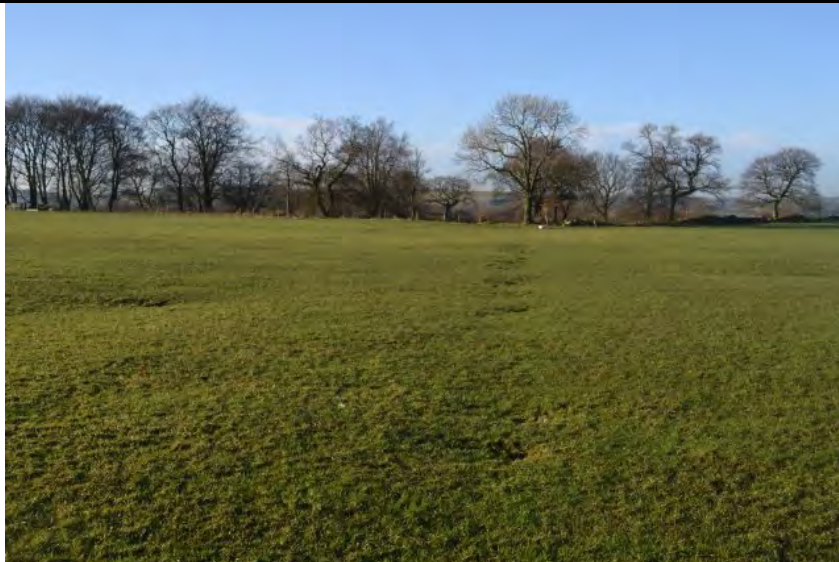
Photograph 8 (facing SW):
Line of depressions
showing path of land drain
heading towards Green
Hills Wood. Rectangular
stone conduits
approximately 100mm
below grass surface.

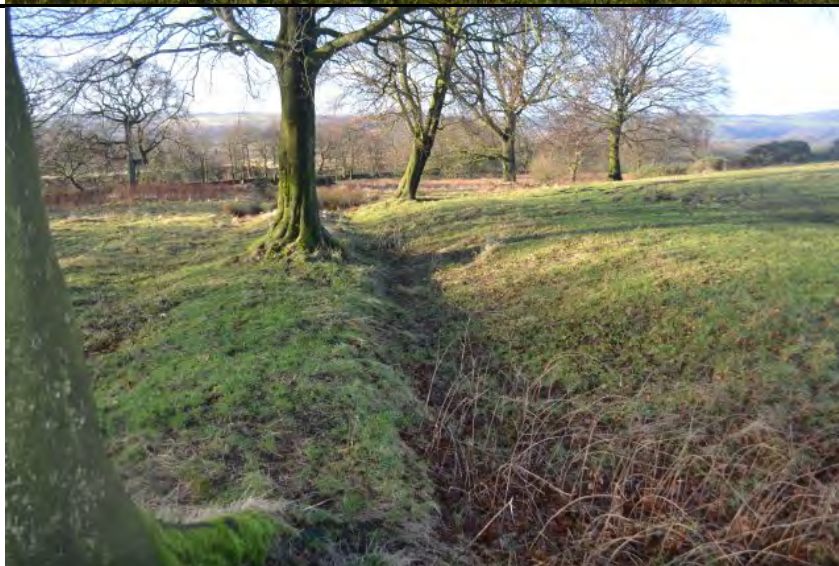
Photograph 9 (facing W):
Typical ditch running
through Green Hills Wood
falling towards Broken
Stone Road.

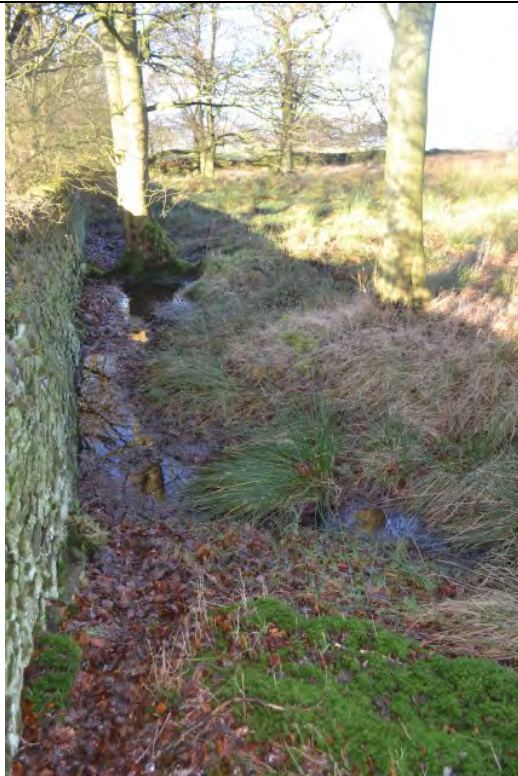
Photograph 10 (facing NW):

Water from ditches ponding adjacent to the boundary wall with Broken Stone Wall in Greenhills Wood.

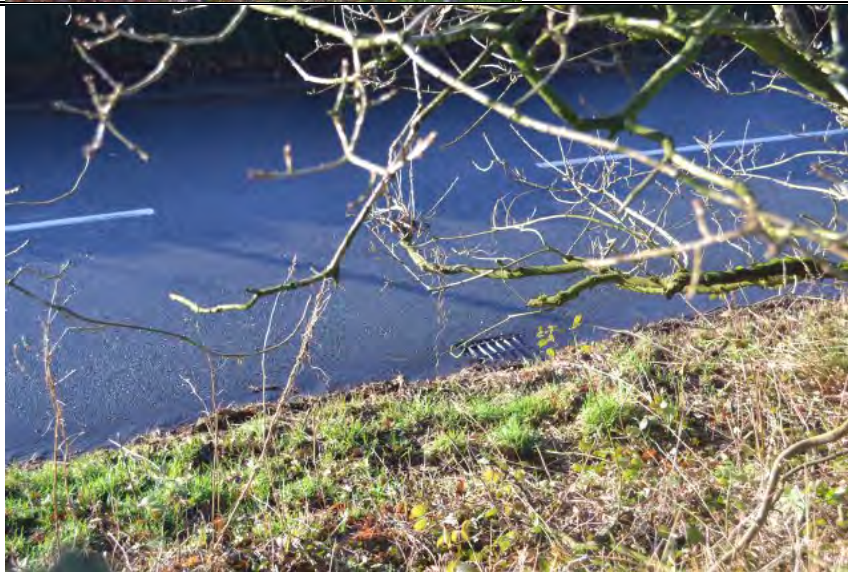
Photograph 11 (facing S):

Gully grating in Broken Stone Road.

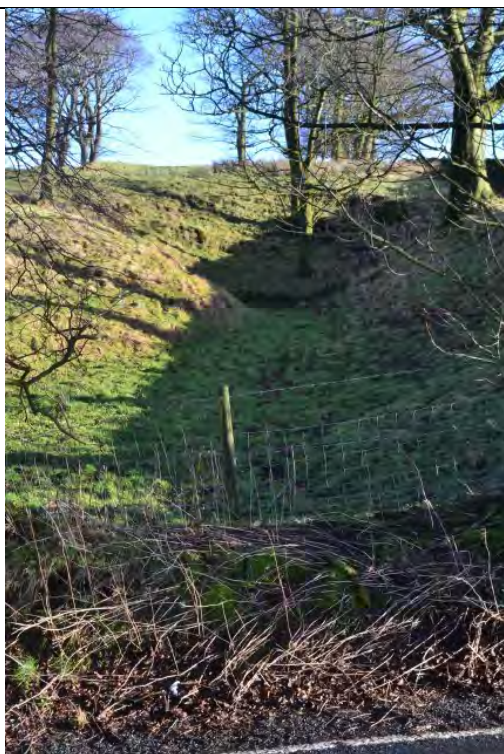
Photograph 12 (facing E):

Hollow east of Gib Lane that appears to catch the water being fed to a trough inside the plot south of the eastern section of Cockridge Wood. The excess entering the filter drain shown in picture 1.

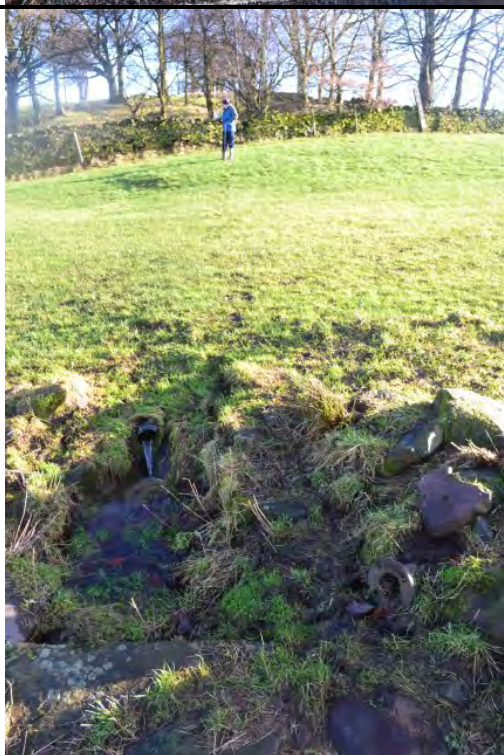
Photograph 13 (facing E):

Trough fed from hollow above, small plastic pipe inflow, stone conduit for overflow to land drainage system. Flanged DI pipe from south was dry.

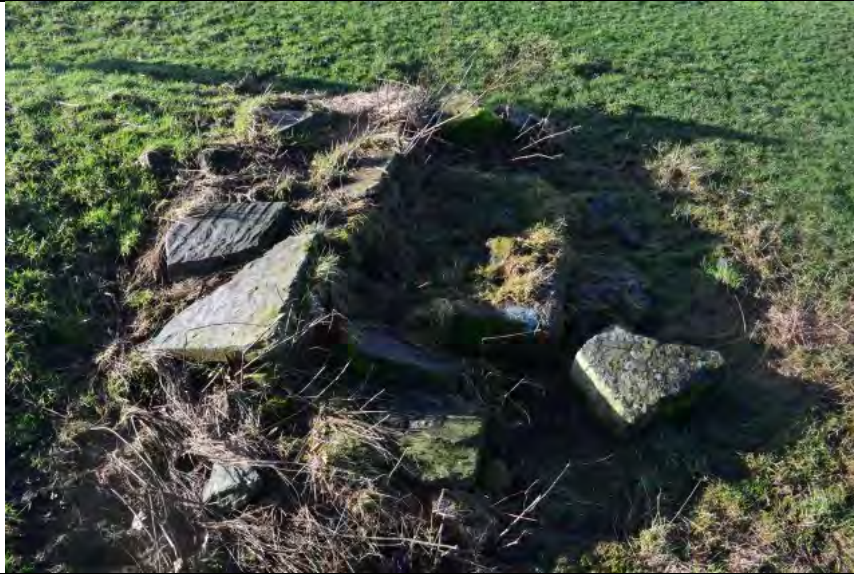
Photograph 14 (facing W):

Second trough in adjacent field fed by land drains south of Cockridge Woods. Overflow heads north to the ditches leading to the open watercourse within the woods.

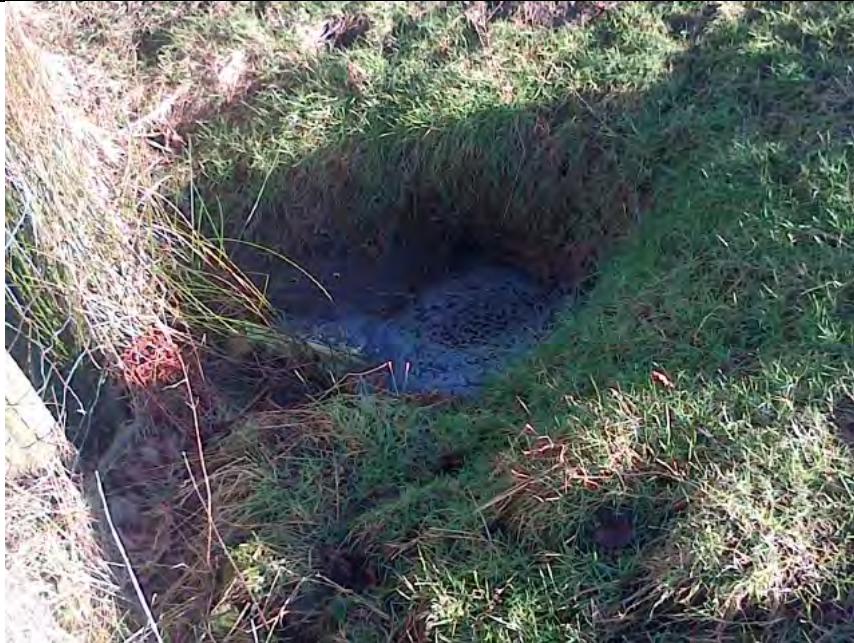
Photograph 15 (facing E):

Outlet from land drainage downstream of above trough fed by land drains south of Cockridge Woods. Outlet leads to a ditch that outfalls to the main watercourse through the wood.

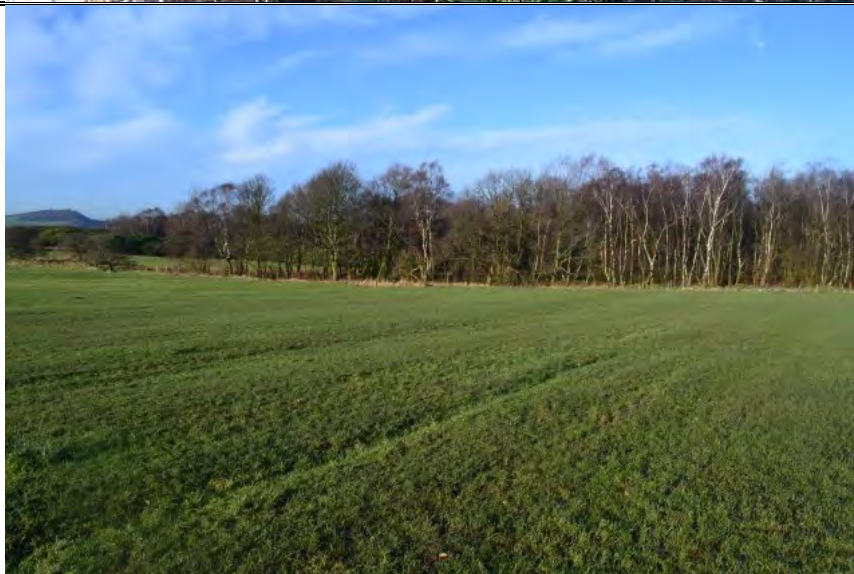
Photograph 16 (facing NW):

Land drain depressions leading towards Cockridge Woods.

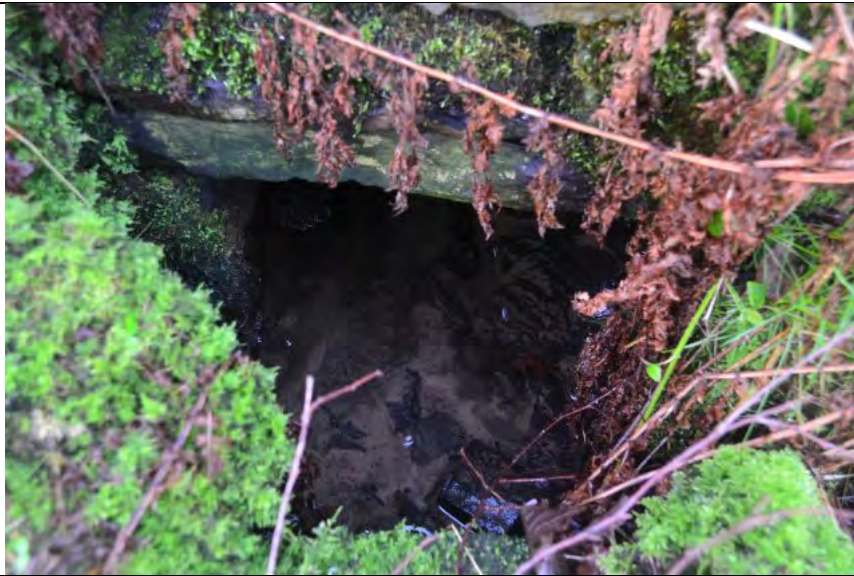
Photograph 17 (facing S):

Assumed outlet from culvert crossing Gib Lane discharging into open watercourse at south end of Cockridge Woods.

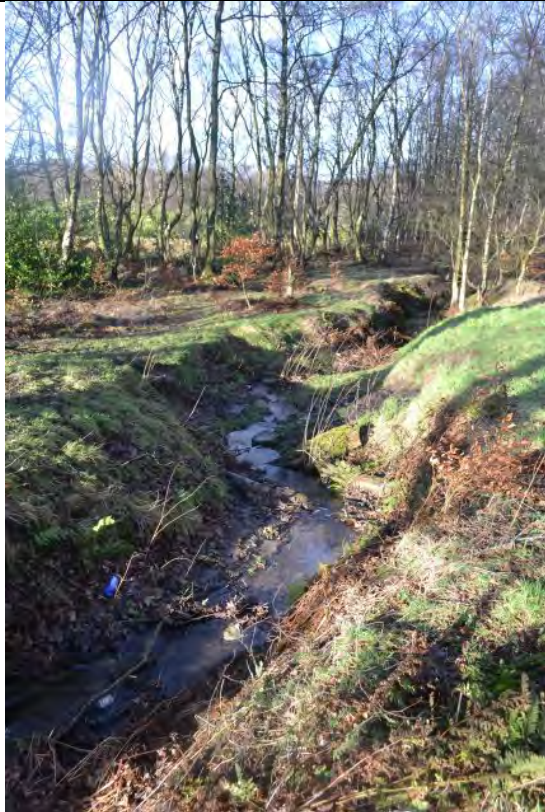
Photograph 18 (facing S):

Open watercourse within Cockridge Woods flowing northwards.

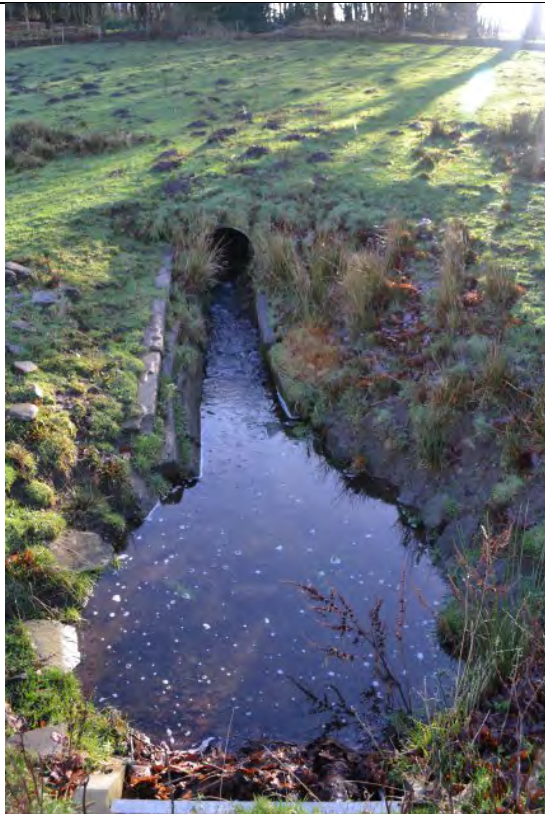
Photograph 19 (facing S):

Open section of the watercourse leaving the north end of Cockridge Woods.

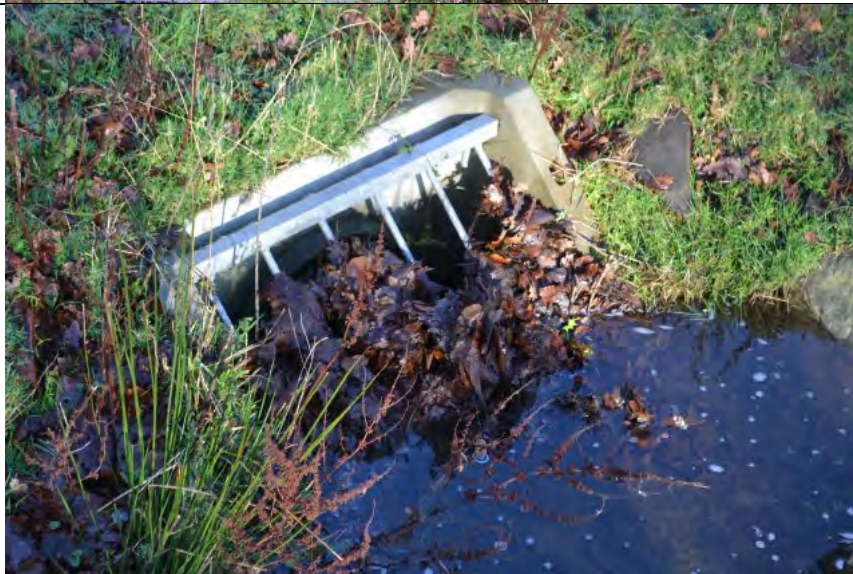
Photograph 20 (facing N):

Blocked trash screen at downstream end of the channel shown above.

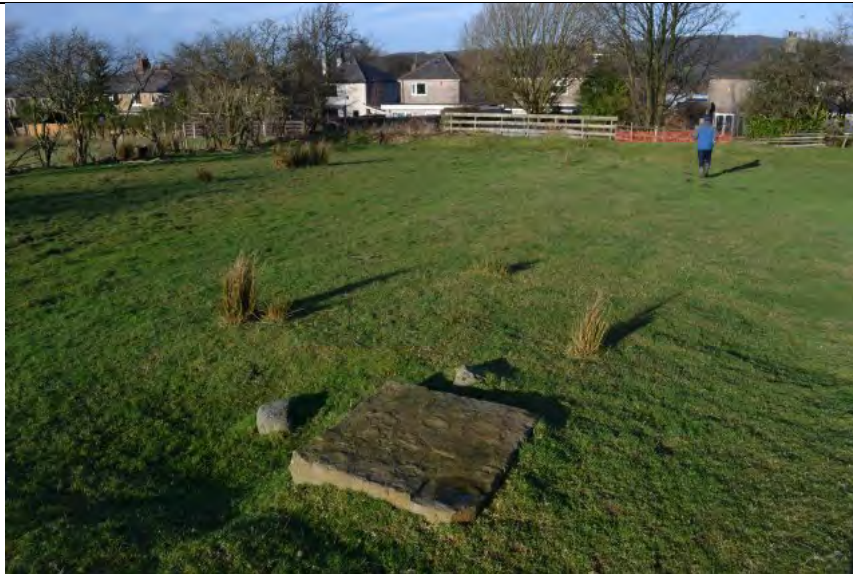
Photograph 21 (facing N):

Stone slabs sealing chambers on line or just offline of the watercourse north of Cockridge Woods. Possible private water supply.

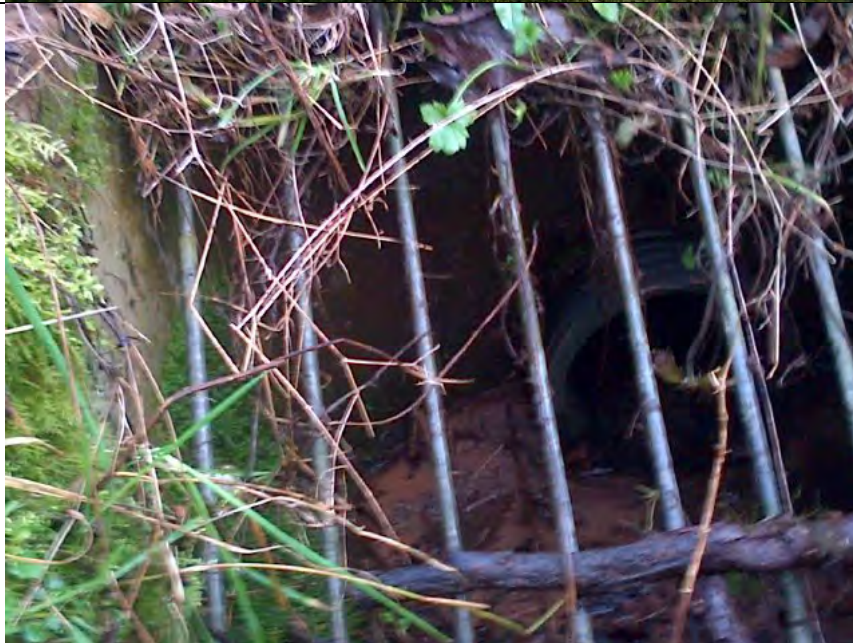
Photograph 22 (facing E):

225mm outfall from intercepting ditch behind housing 451 to 427 Livesey Branch Road that appears to connect into the 450mm piped watercourse.

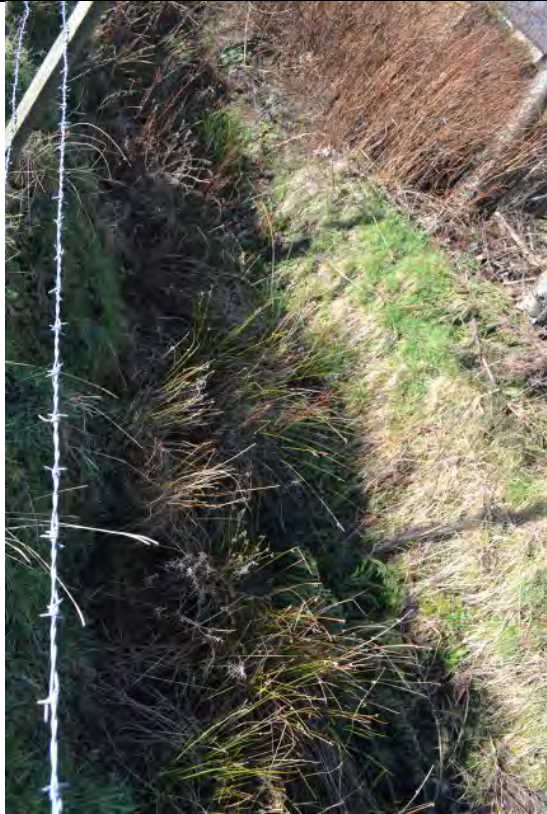
Photograph 23 (facing W):

Intercepting ditch behind housing 451 to 427 Livesey Branch Road. Outfalls via 225mm plastic pipe that appear to connect into the 450mm piped watercourse.

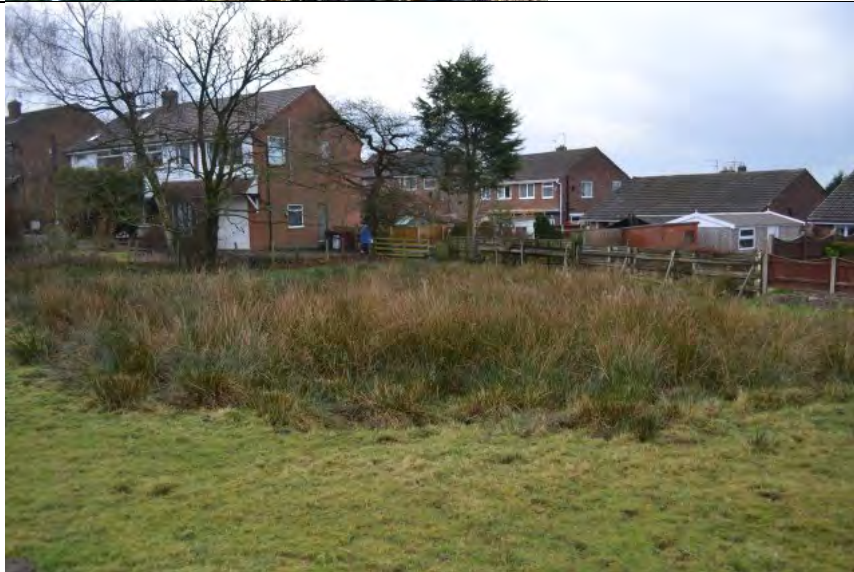
Photograph 24 (facing W):

Marshy/Pond area behind housing in western corner of the site behind St Michael's Close.

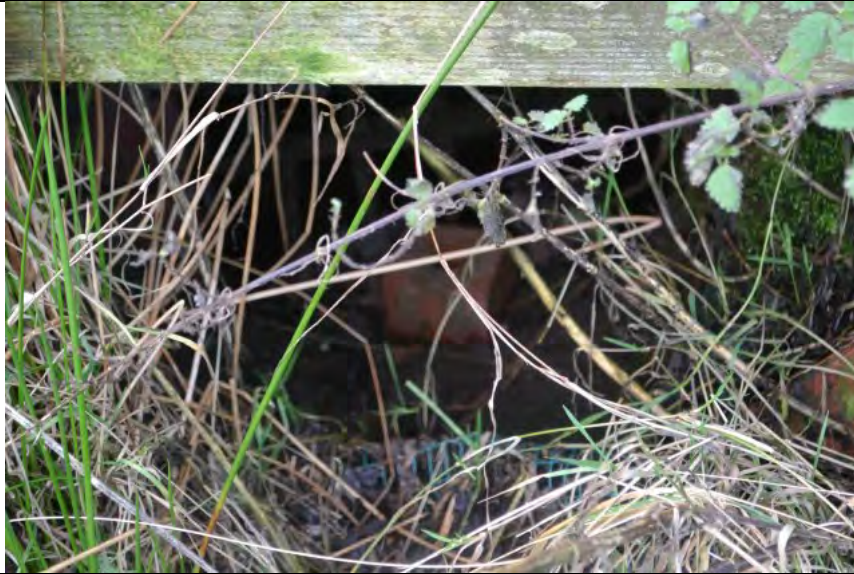
Photograph 54 (facing N):
Overflow from Marshy/Pond area behind housing towards western corner of the site behind St Michael's Close.

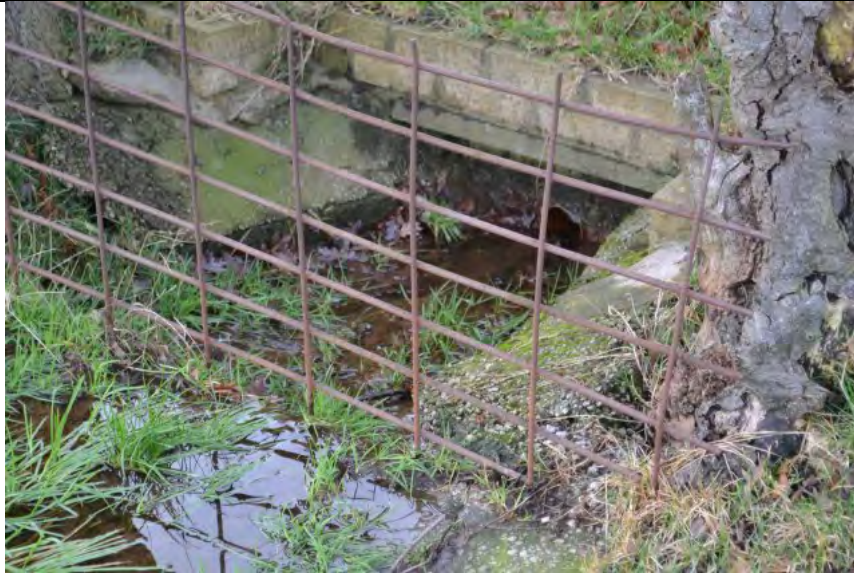
Photograph 26 (facing N):
Small Resident/Builder constructed overflow, located towards Marshy/Pond area behind housing in western corner of the site behind St Michael's Close.

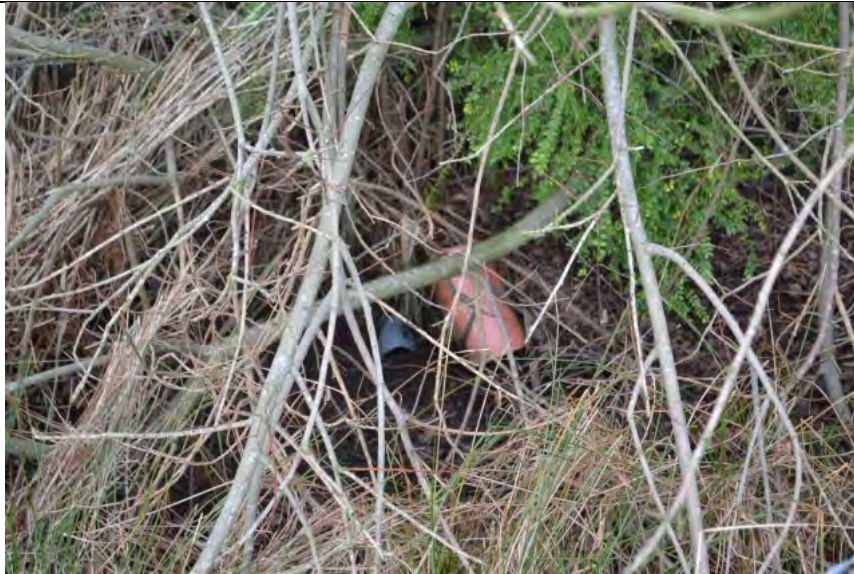
Photograph 27 (facing N):
Small outlet from ditch behind 531b Livesey Branch Road.

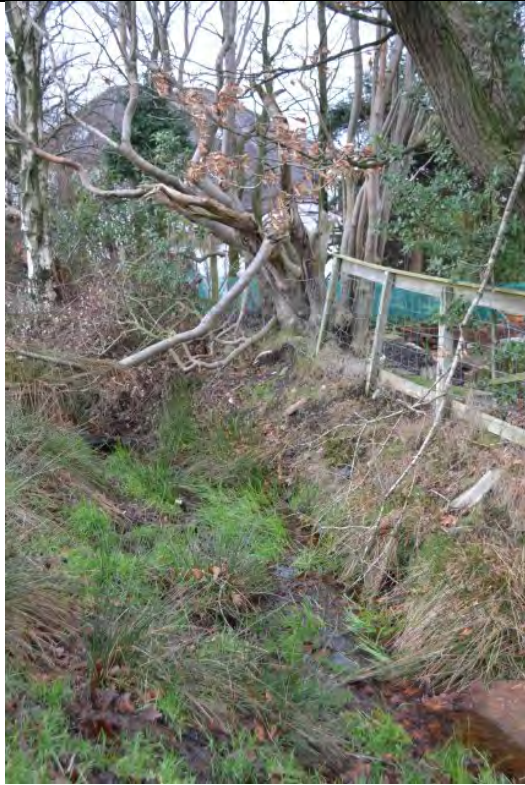
Photograph 28 (facing W):

Ditch behind 529 to 531b Livesey Branch Road. To collect water from marshy area possible outfall behind 531b.

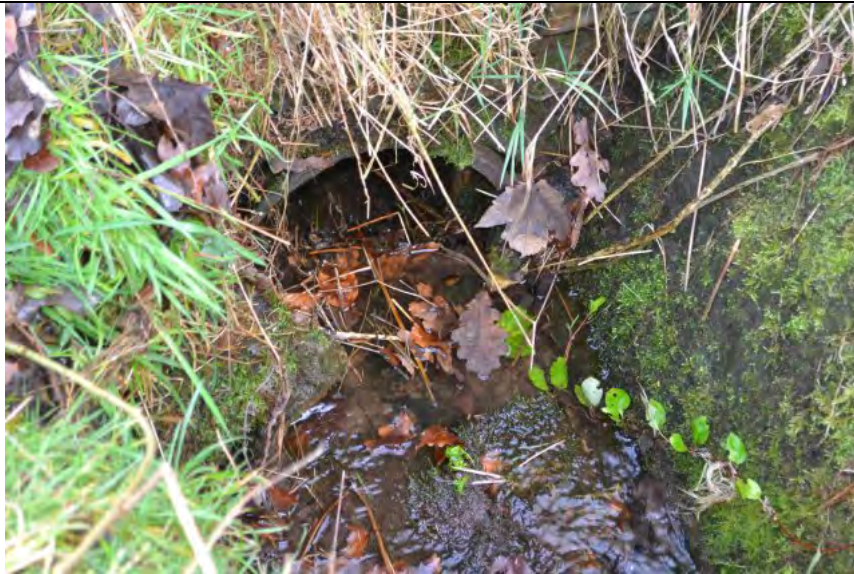
Photograph 29 (facing W):

300mm outlet from watercourse shown in photos 5 & 6 behind 527 Livesey Branch Road. Connects to UU SW sewer in the road, runs between 527 and 529a.

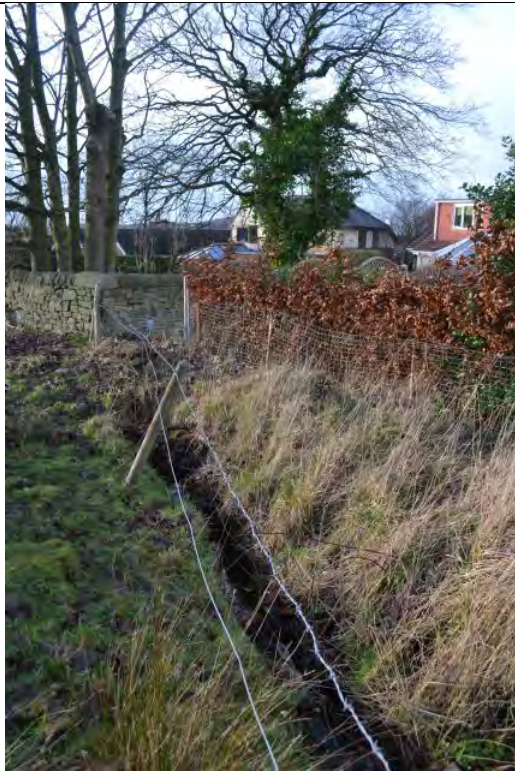
Photograph 30 (facing W):

Connecting ditch leading to the 300mm outlet above from the watercourse.

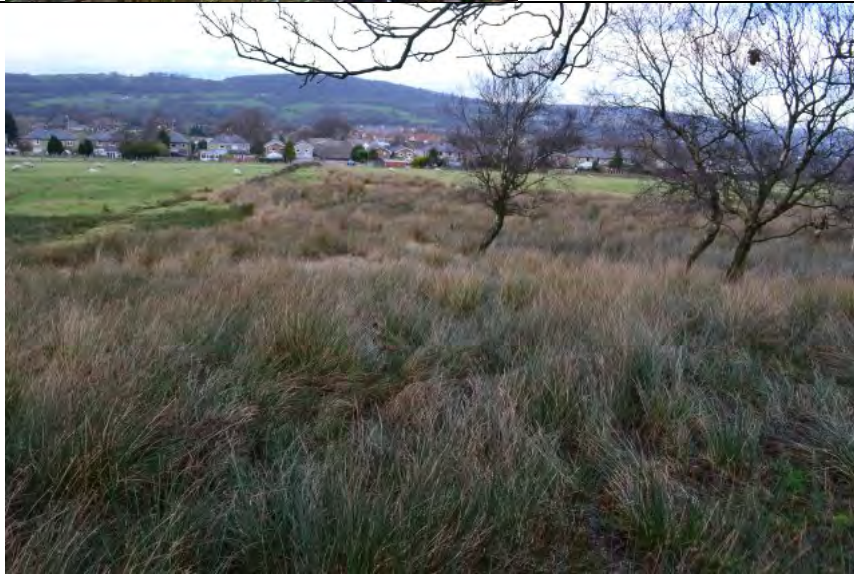
Photograph 31 (facing N):

Marshy area at the north end of Cockridge Woods western section.

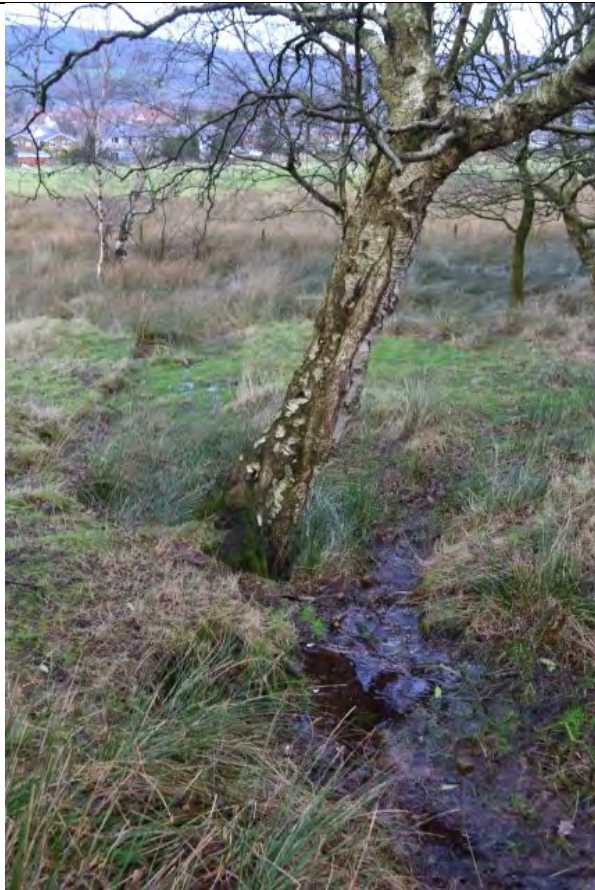
Photograph 32 (facing N):

Outfall from piped drain discharging towards the ditch surrounding the north end of Cockridge Wood western section.

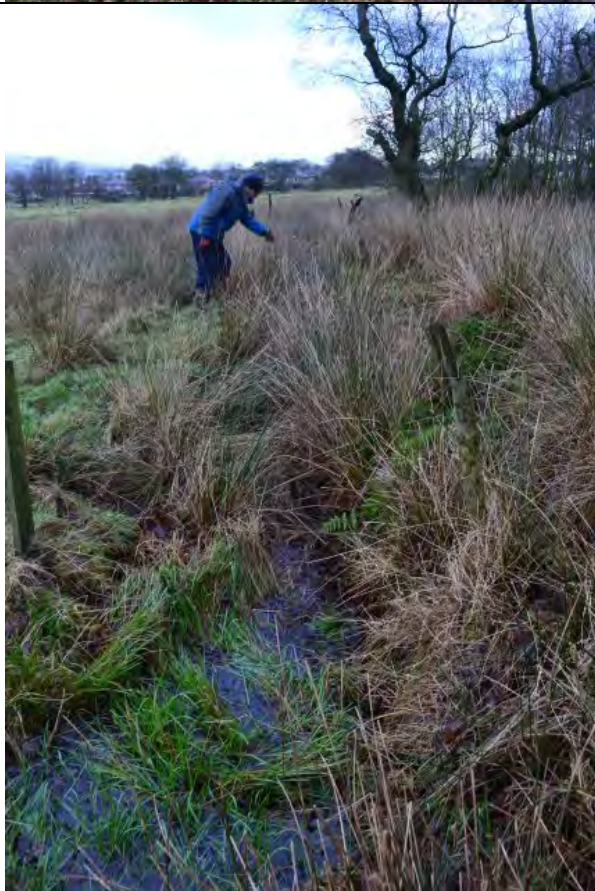
Photograph 33 (facing N):

The ditch surrounding the north end of Cockridge Wood western section.

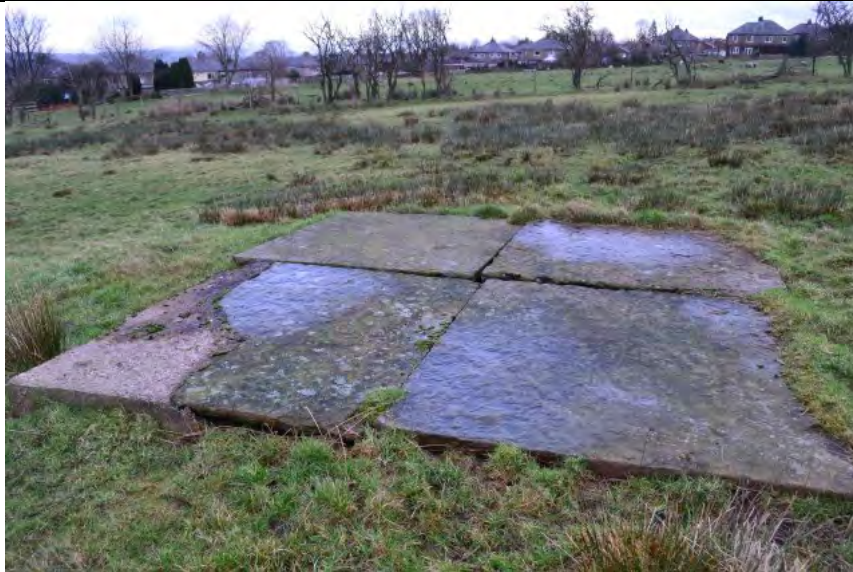
Photograph 34 (facing N):

Water Tank to the north of Cockridge Wood western section. Possibly old private water supply to properties off Livesey Branch Road.

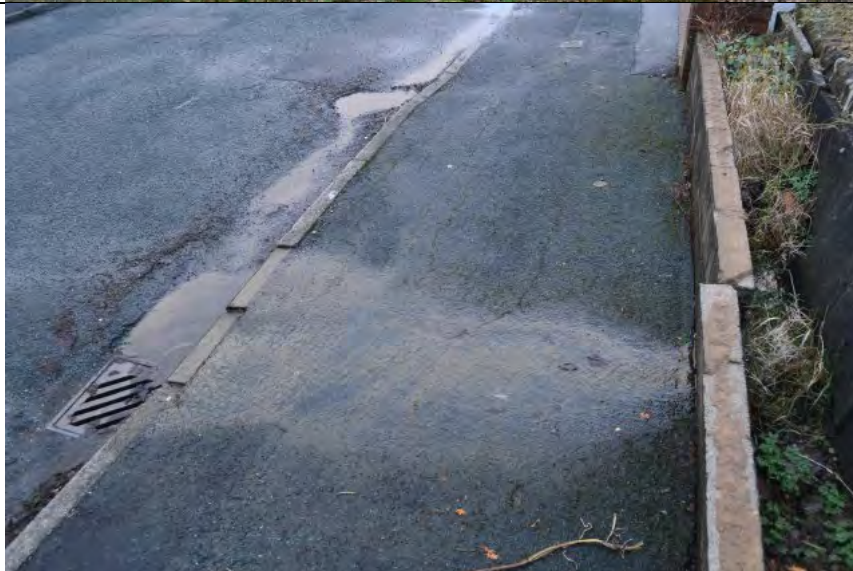
Photograph 35 (facing E):

Water crossing pavement on St Michael's Close, adjacent to number 19. Source not determined.
