**LAND AT
GIB LANE
BLACKBURN**

**FLOOD RISK ASSESSMENT
& OUTLINE DRAINAGE STRATEGY**

Ref: FRA 13 1077-FINAL

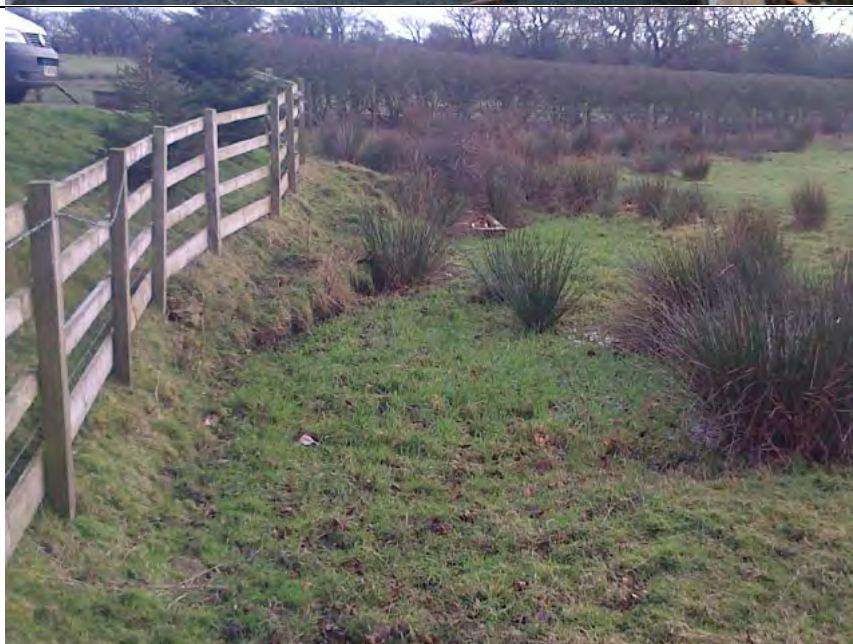
Photograph 36 (facing E):

Waterlogged area south of Horden Farm containing trough and a number of outlets from the building area.

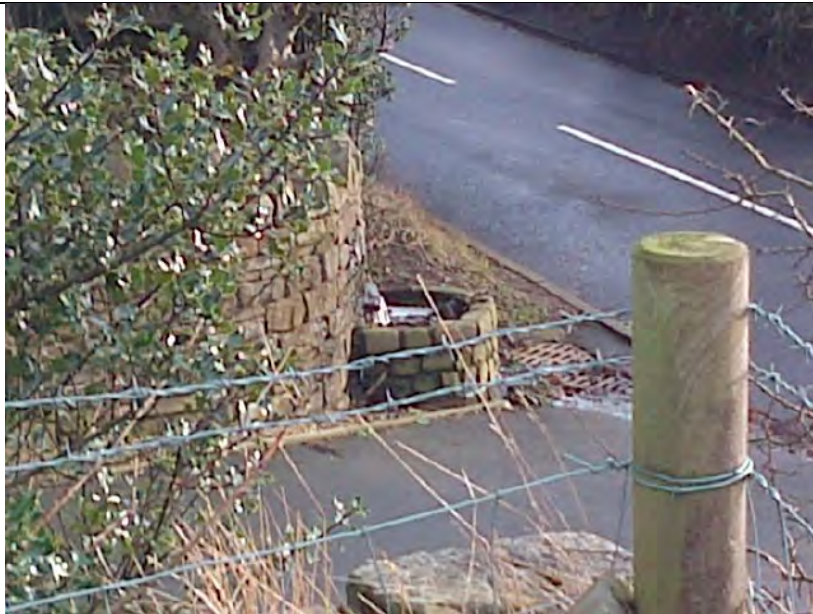
Photograph 37 (facing SE):

Naturally fed water trough at the entrance to Horden Farm off Horden Rake with gullies and linear drainage catching overflow and carriageway runoff and discharging to the verge drainage.

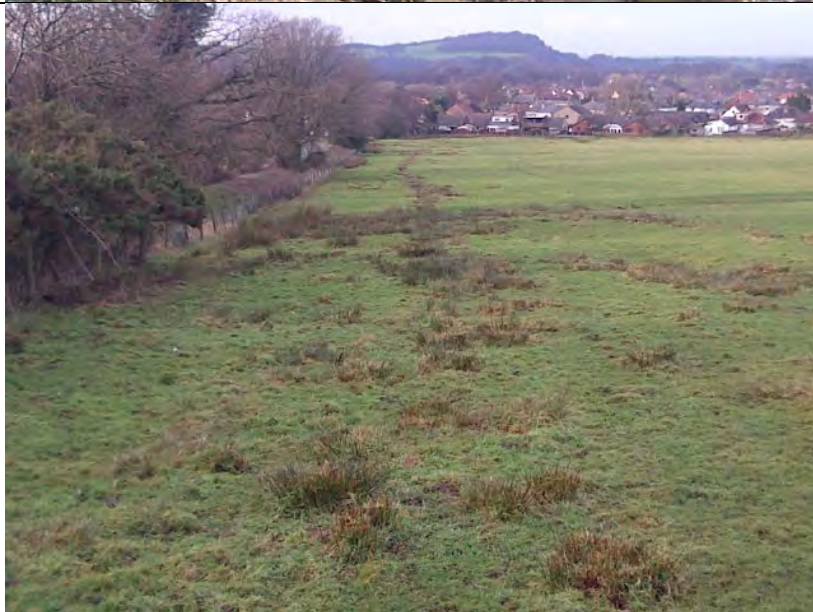
Photograph 38 (facing NW):

Line of marsh grass running parallel to Horden Rake possibly indicating the line of land drainage leading to the western corner of the site.

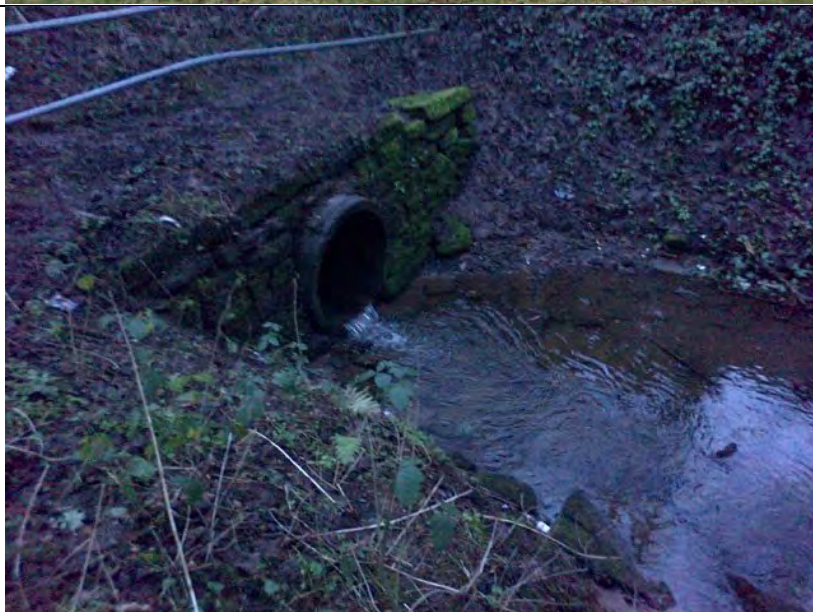
Photograph 39 (facing NW):

Outfall of buried and culverted watercourse draining western corner of the plot. Located to the west of the Canal after flowing through diversion running along the northern side of Livesey Branch Road.

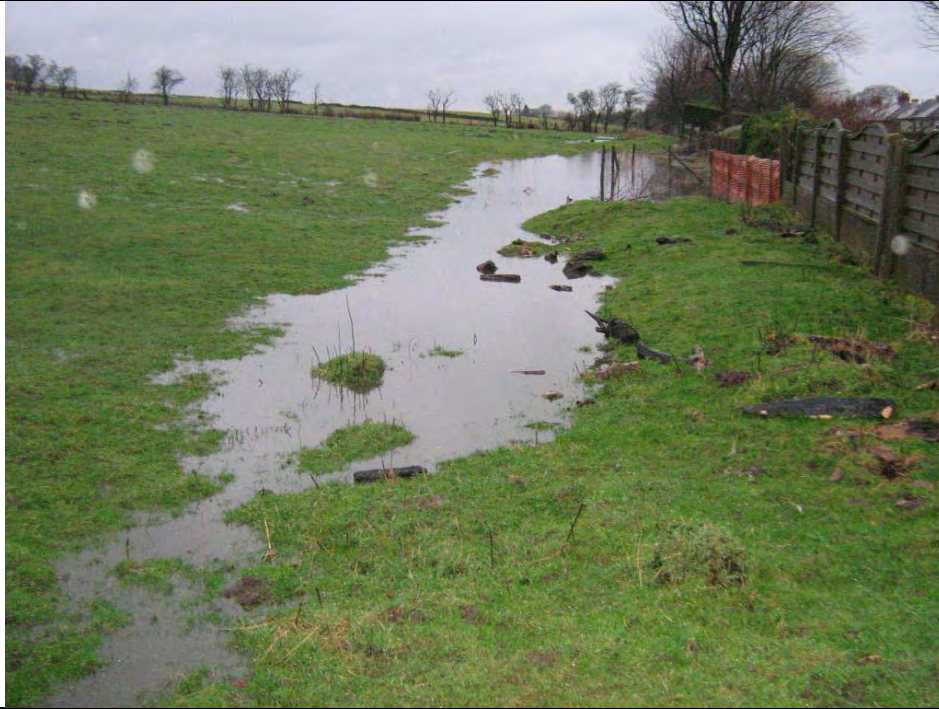
Photograph 1 (facing W):

View of plot immediately to the rear of Livesey Branch Road showing build-up of surface water adjacent to easternmost residential properties.

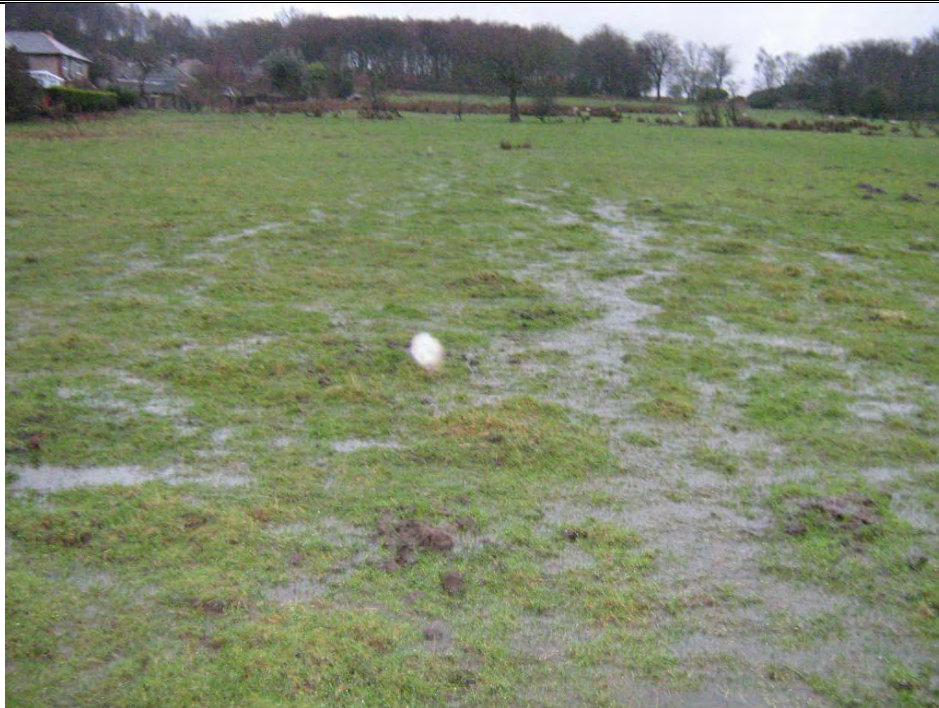
Photograph 2 (facing S):

Surface Water running over field towards above area.

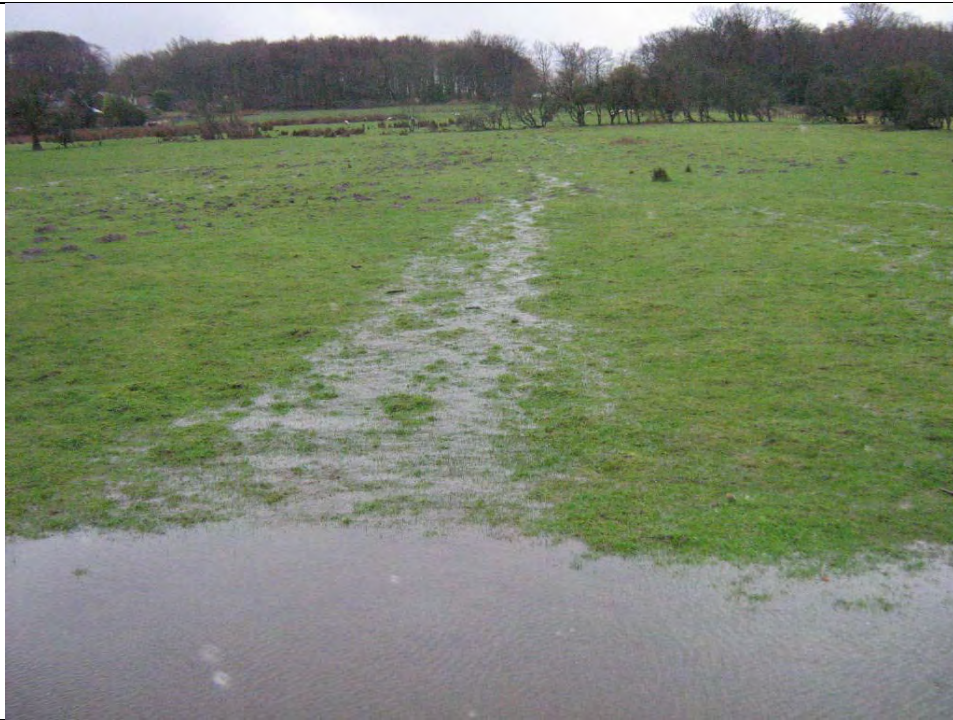
Photograph 3
(facing S):
As above.

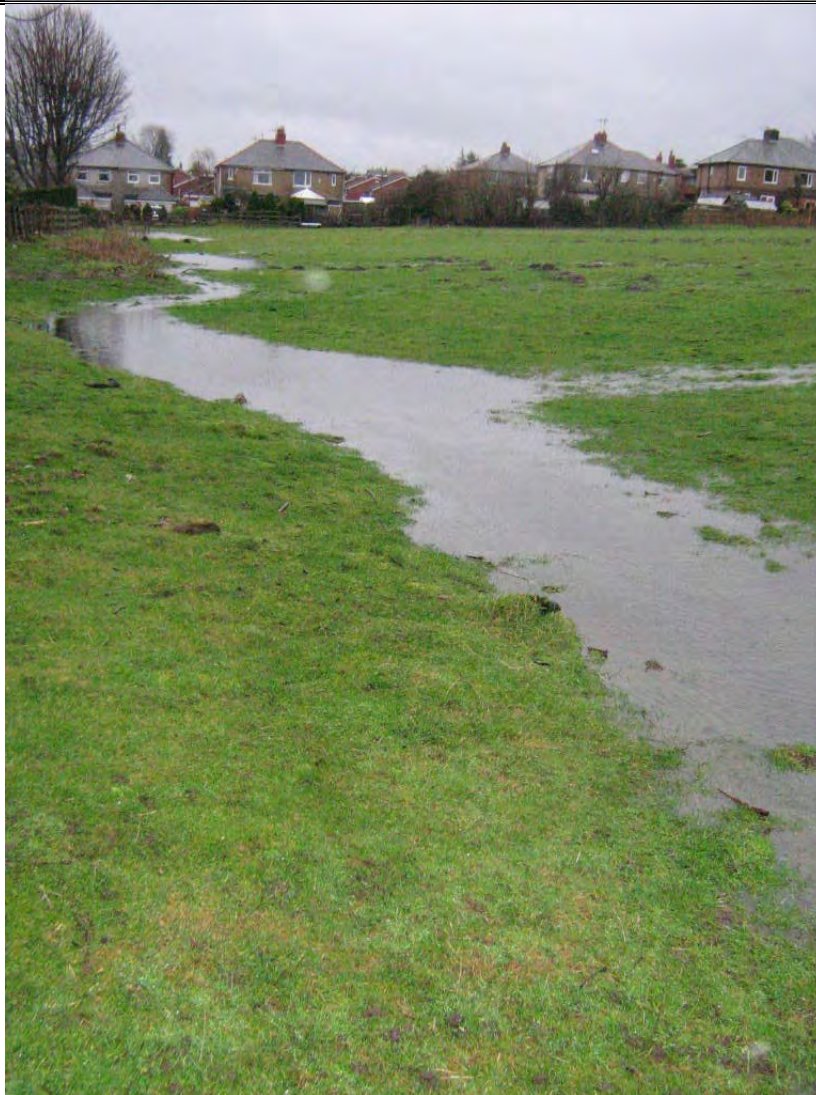
Photograph 4
(facing E):
View of plot immediately to the rear of Livesey Branch Road showing build-up of surface water adjacent to easternmost residential properties.

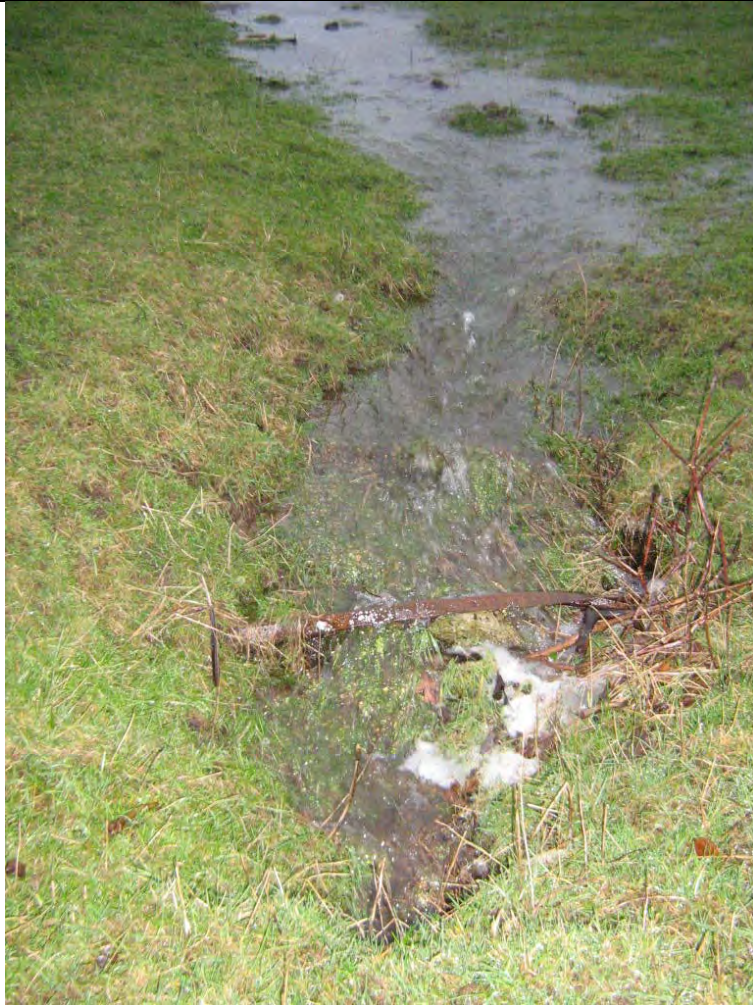
**Photograph 5
(facing S):**
Water entering
culverted
watercourse
near the rear of
419 Livesey
Branch Road.

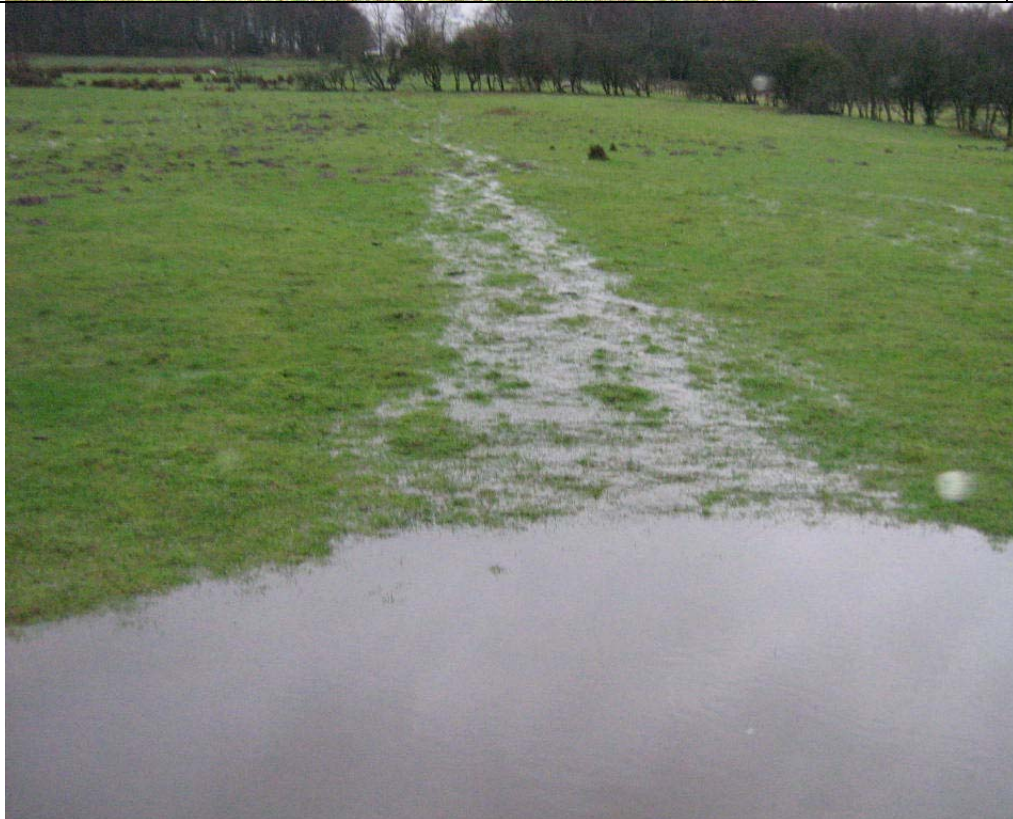
**Photograph 6
(facing S):**
Surface Water
running over
field towards
above area.

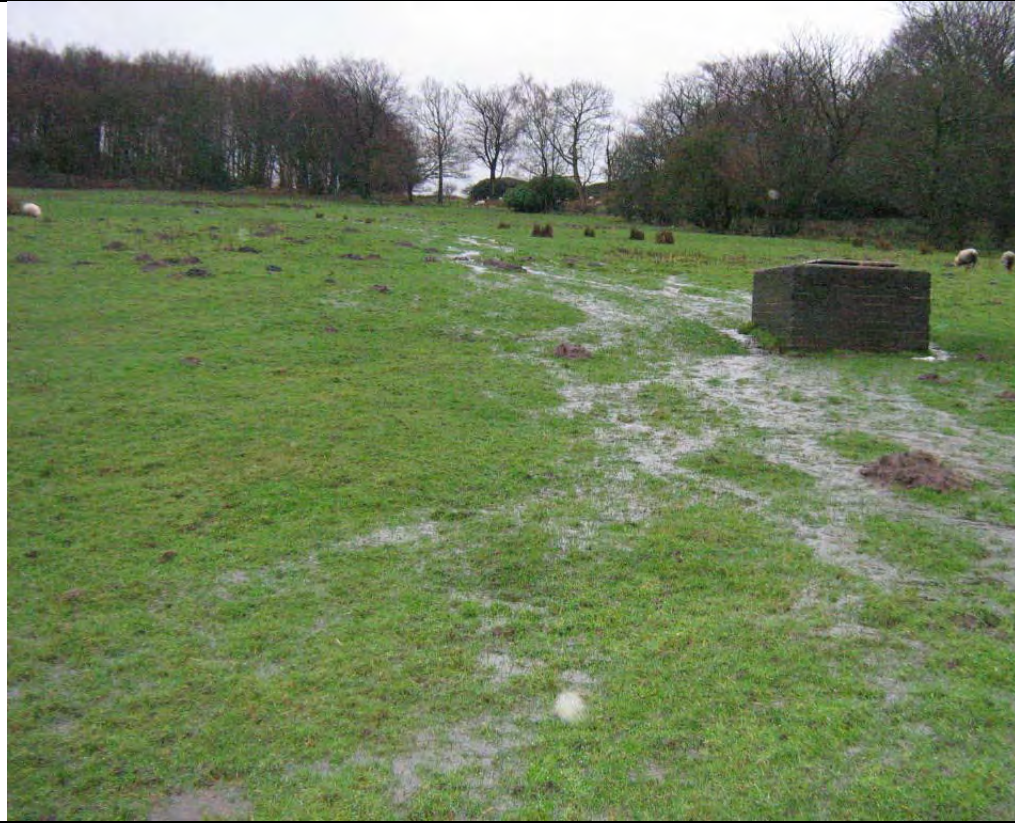
**Photograph 7
(facing S):**
Surface Water
running over
field towards
above area.
